**Surveys of corrosion on cannons on the
wreck of the Coronation**

BSAC First Class Diver Examination

25th and 26th June, 2011

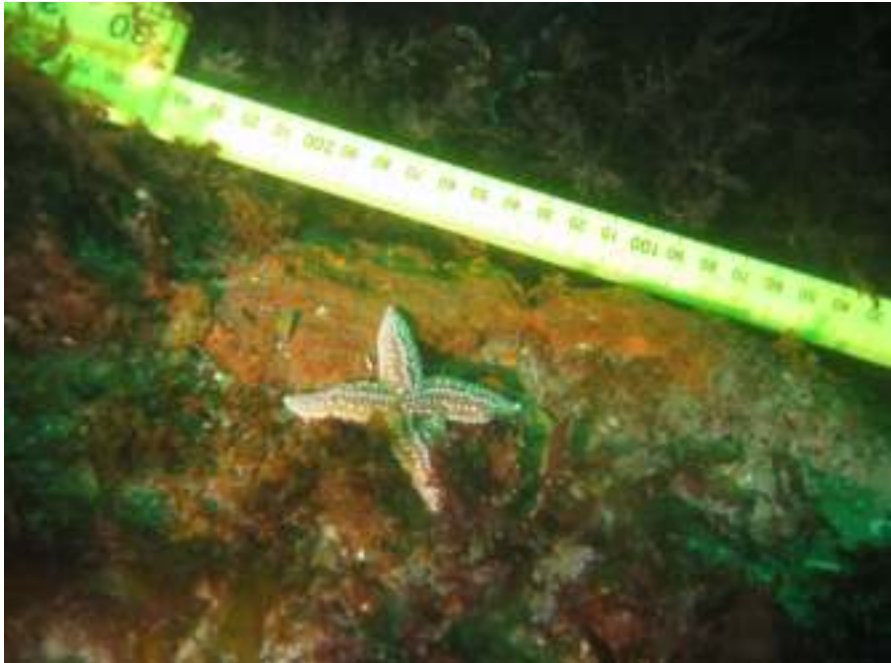
Buoy	Cannon	Team	Sketch	Length (mm)	Height (mm)
10	2	AN & CY

100x30	30

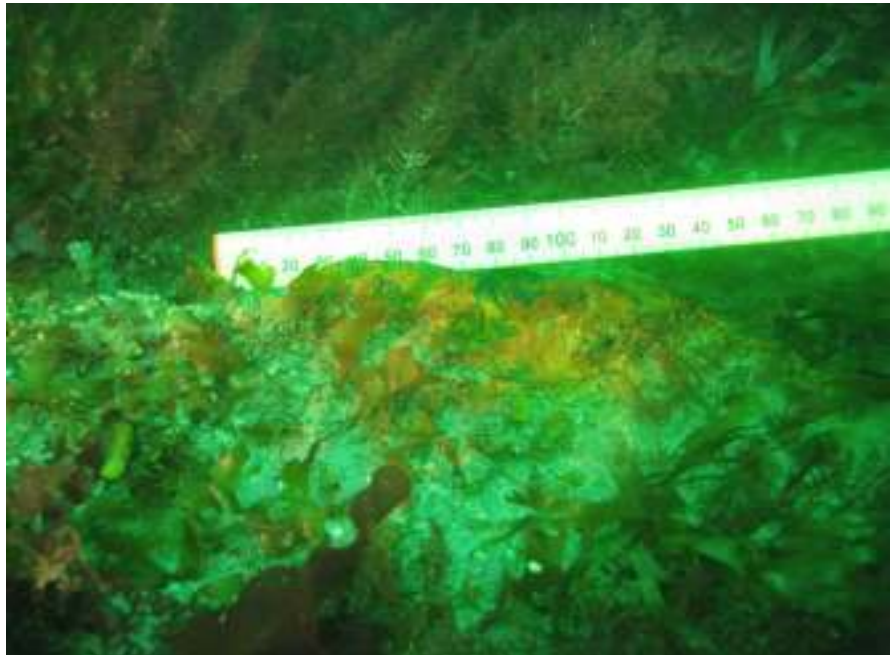
Buoy	Cannon	Team	Sketch	Length (mm)	Height (mm)
10	2	AN & CY

100x40	10

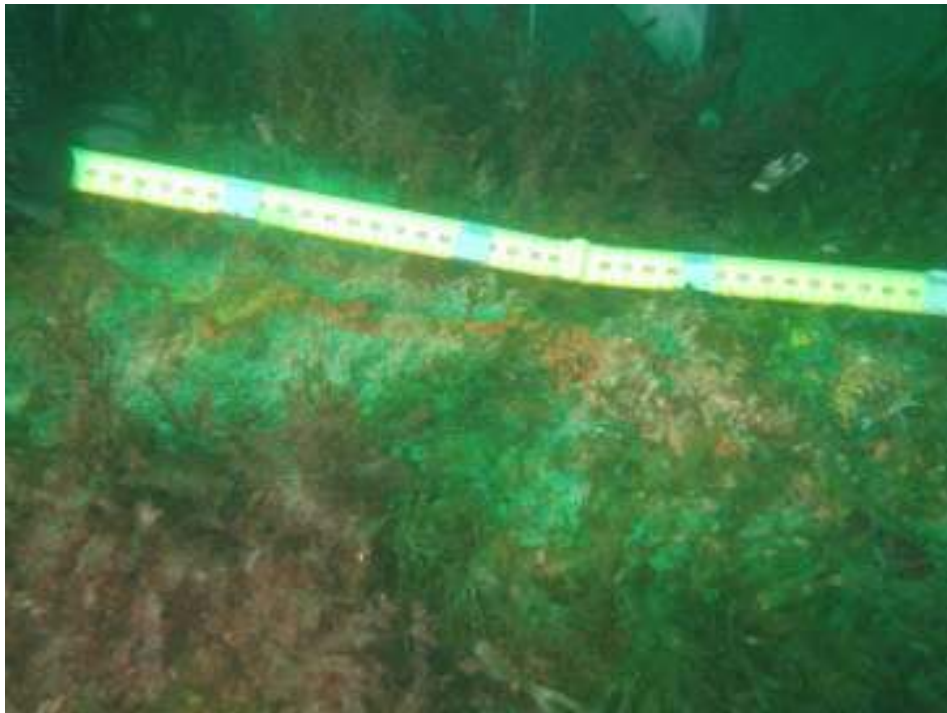
Buoy	Cannon	Team	Sketch	Length (mm)	Height (mm)
3	3	AN & CY

1700x10	10

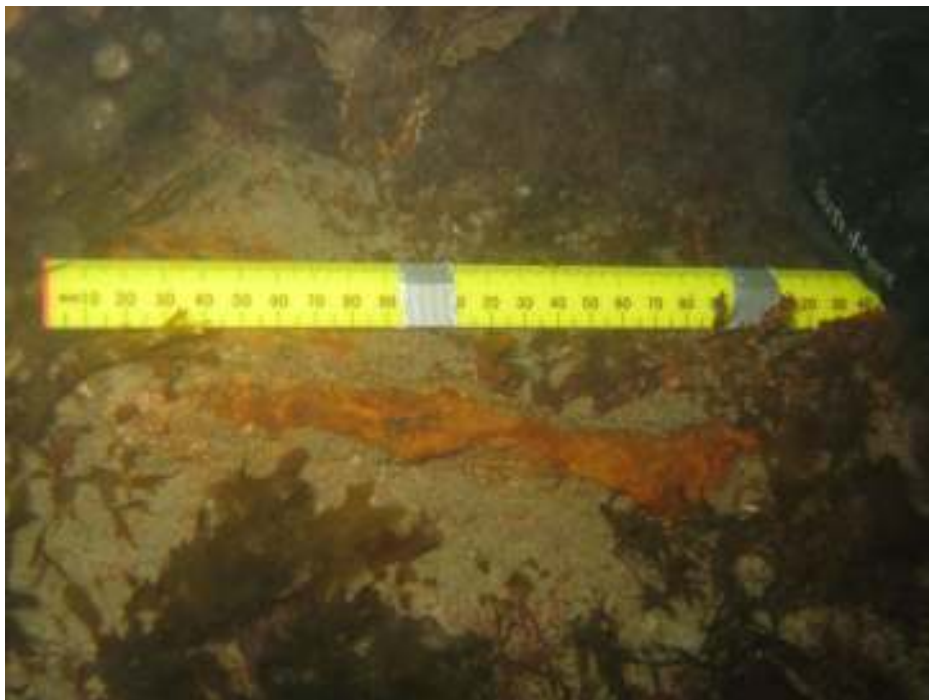
Buoy	Cannon	Team	Sketch	Length (mm)	Height (mm)
3	4	AN & CY

200x20	10

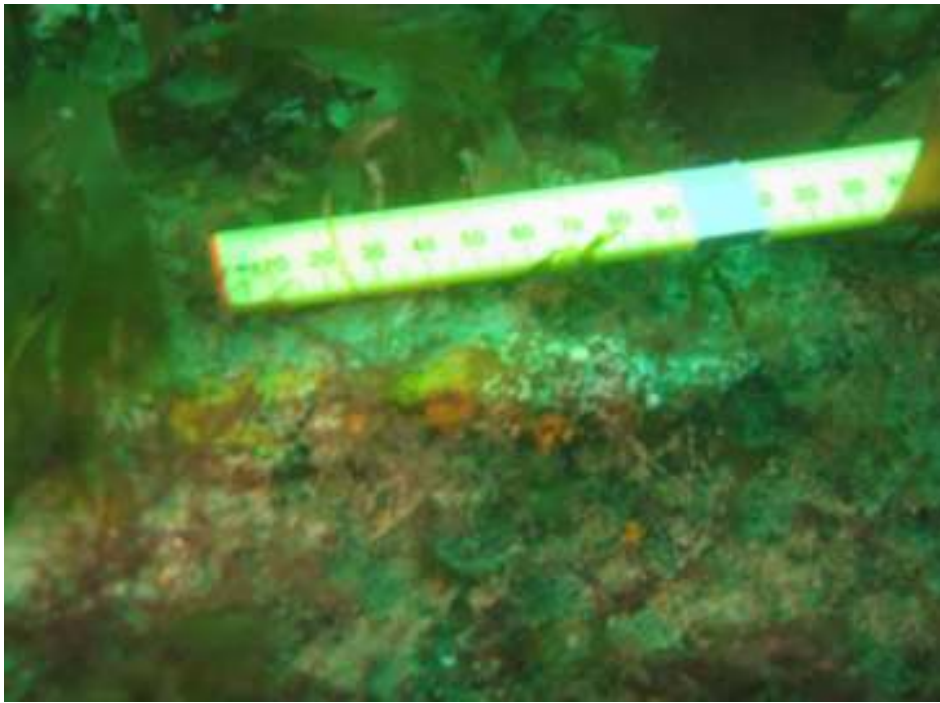
Buoy	Cannon	Team	Sketch	Length (mm)	Height (mm)
3	4	AN & CY

1500x15	25

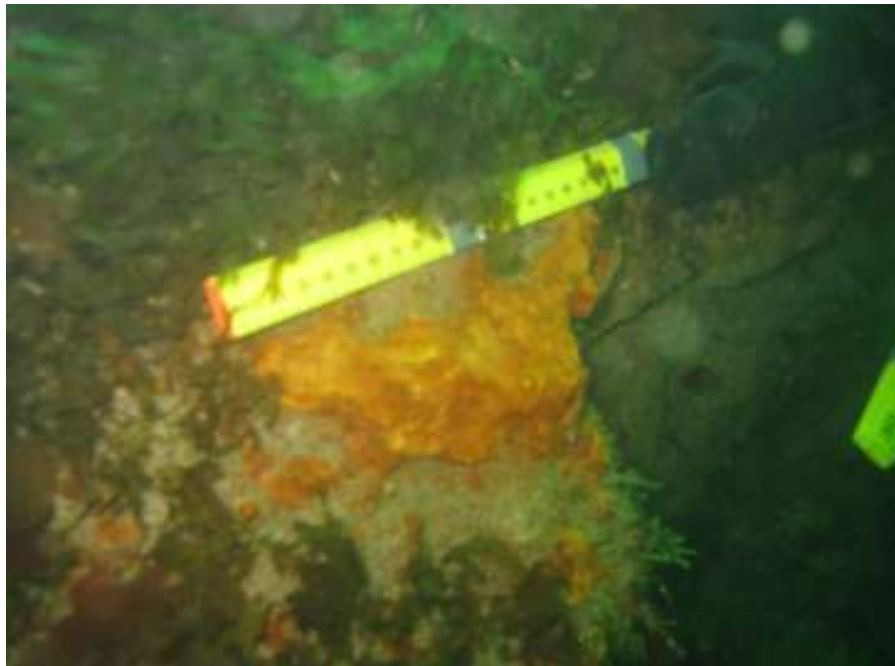
Buoy	Cannon	Team	Sketch	Length (mm)	Height (mm)
4	5	AN & CY

800	20

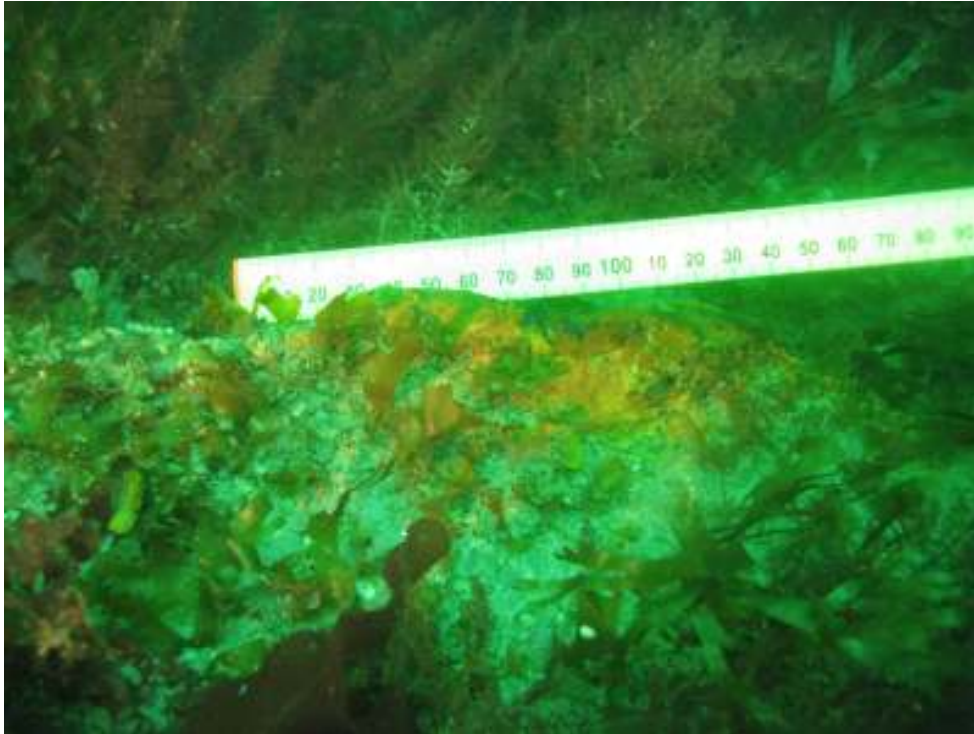
Buoy	Cannon	Team	Sketch	Length (mm)	Height (mm)
2	7	AN & CY

Corrosion eruptions were identified on nine cannons on the offshore site, in general eruptions were roughly rectangular extending along the length of the cannon with expansion restricted in the vertical plane. The exception to this is the site on cannon 7 which is squarer in shape (90x80mm).

90x80	10

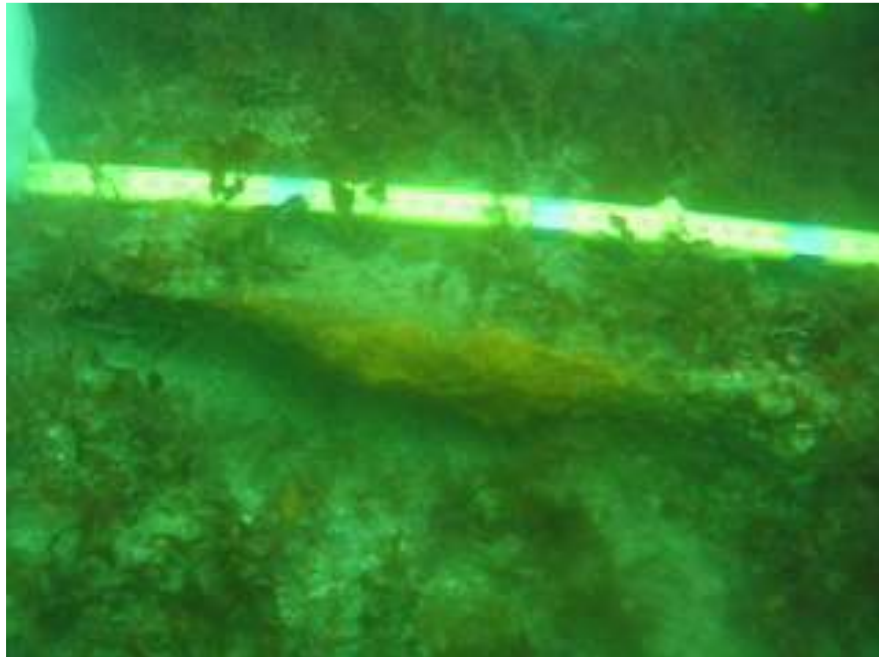
Buoy	Cannon	Team	Sketch	Length (mm)	Height (mm)
9	9	LW & GC

470	110

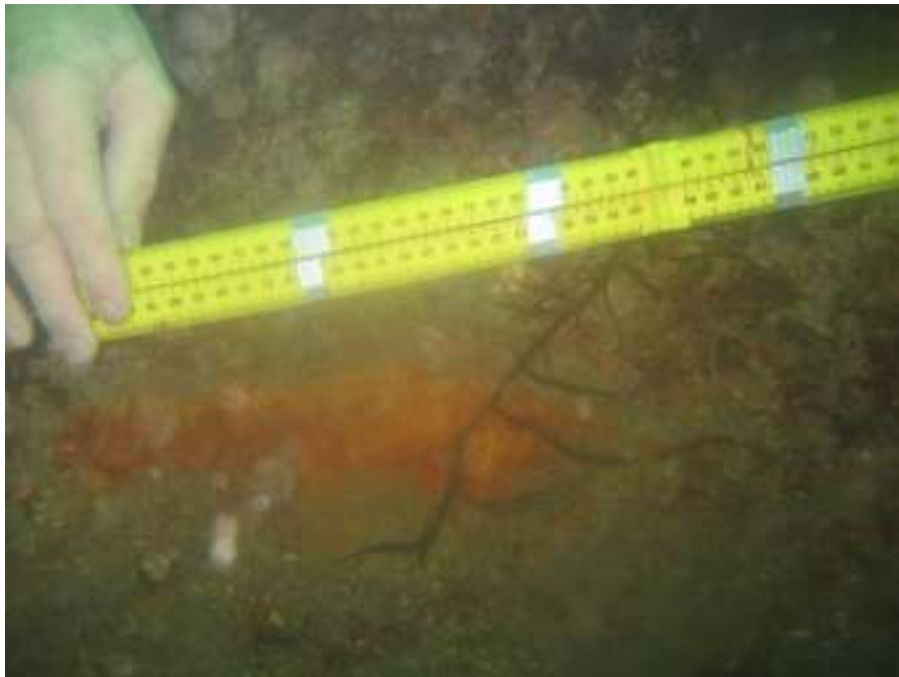
Buoy	Cannon	Team	Sketch	Length (mm)	Height (mm)
8	10	LW & GC

220	140

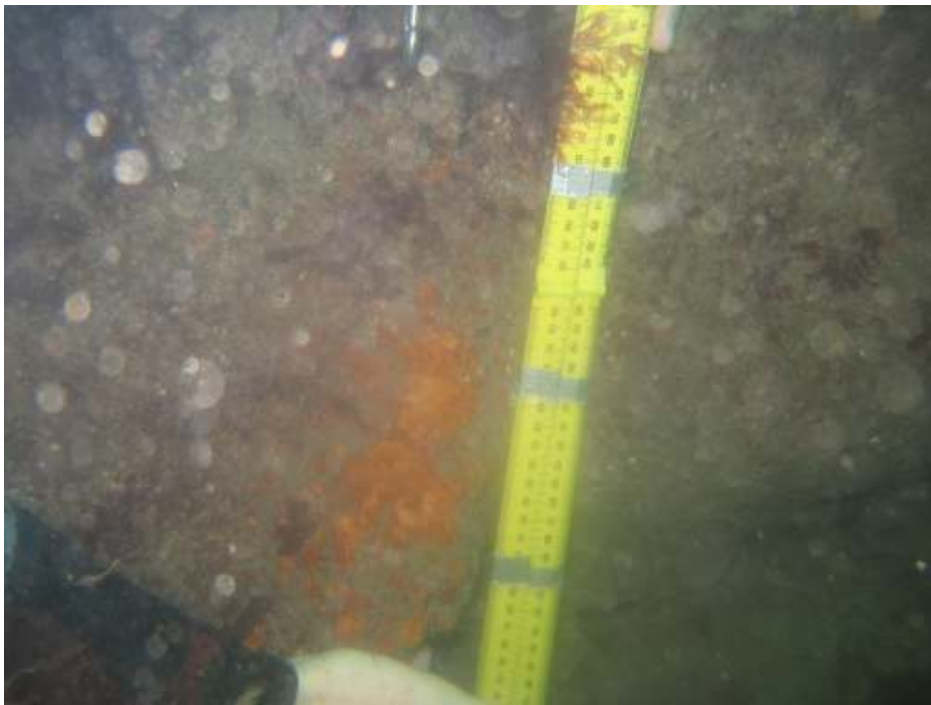
Buoy	Cannon	Team	Sketch	Length (mm)	Height (mm)
8	10	LW & GC

230	130

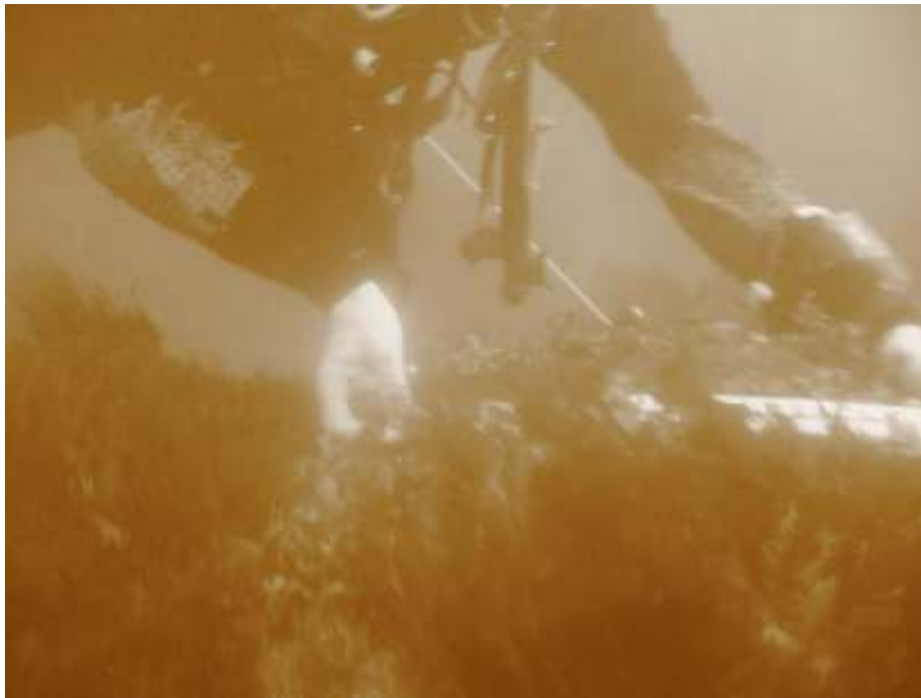
Buoy	Cannon	Team	Sketch	Length (mm)	Height (mm)
7	14	LW &GC

460	190
