# Survey of the Coronation Wreck's Cannon and Best Bower Anchor

FCD Project Report, 8-9 June 2019

The project task for the First Class Diver exam dated 8-9 June 2019 was to survey portions of the protected wreck site of HMS Coronation. There were two specific tasks:

1. As part of a continual monitoring project, survey and record the current state of the corrosion fins on the cannon at the Offshore Site
2. Survey and record the recently located large longshank anchor believed to be the "Best Bower Anchor" that was being deployed when the Coronation foundered.

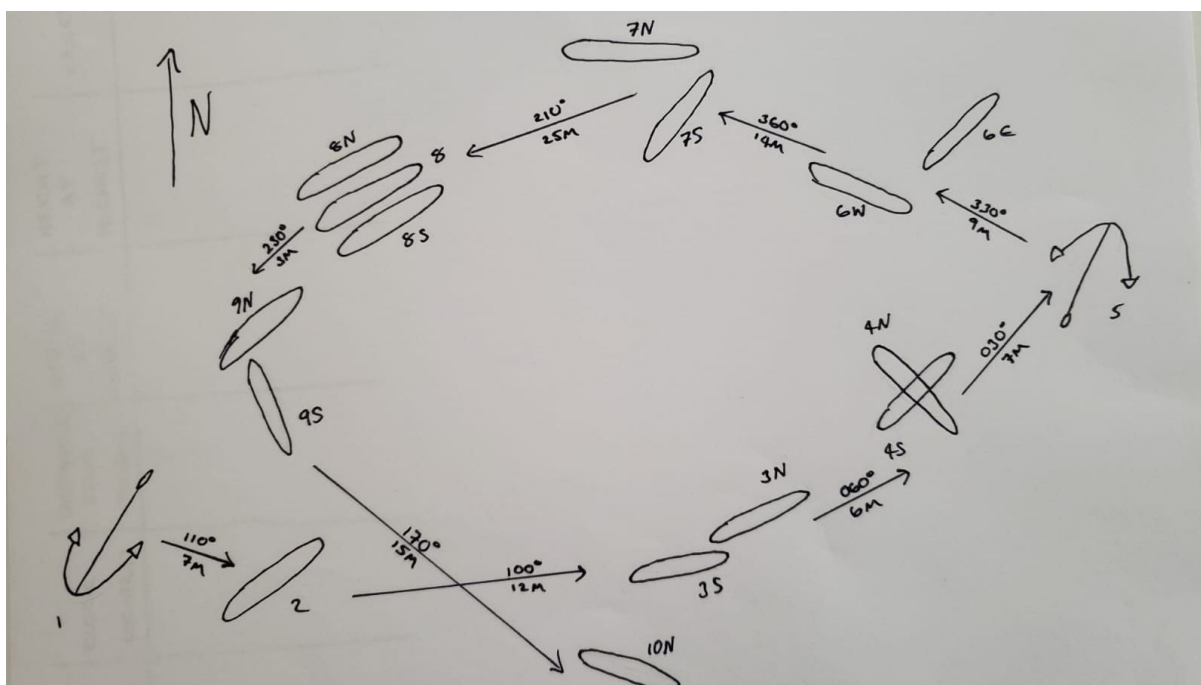
Figure 9. Outline of Offshore Site showing cannon locations (not to scale)

1. Survey Station 2, 4, 7, and 9

Stations 1 and 5 were not to be surveyed as they contain anchors and not cannon. The westerly cannon at station 7 was also not to be surveyed due to its inaccessibility.

Cannon Number refers to the number of cannon as shown on site map. These were further divided within each station using cardinal points to identify each individual cannon. An example of this is 3N and 3S as seen in Figure 9. Clock location refers to the orientation of corrosion fins found on the cannon. Surveyors were to look down the length of the cannon facing the muzzle. The highest point of the circumference of the cannon would then be marked 12 and followed from 1 through to 12 clockwise like a clock face. The approximate location of the corrosion fin would then be noted against this clock face. Distance from muzzle was used to identify where along the length of the cannon the corrosion fin was growing. The distance was measured from the muzzle to the start of the corrosion fin. This was the area where the cannon surface started to rise or change to orange in colouration. Width at widest was used to identify the measurement at widest point of the corrosion fin. This did not necessarily have to be from the base of the fin and was around the circumference of the cannon. Height at highest was to be measured from base of corrosion fin at cannon's surface to the highest point the corrosion fin grew to approximately perpendicular to the cannon's surface. Length was the total length of the corrosion fin from the closest point to muzzle to closest point to breach.

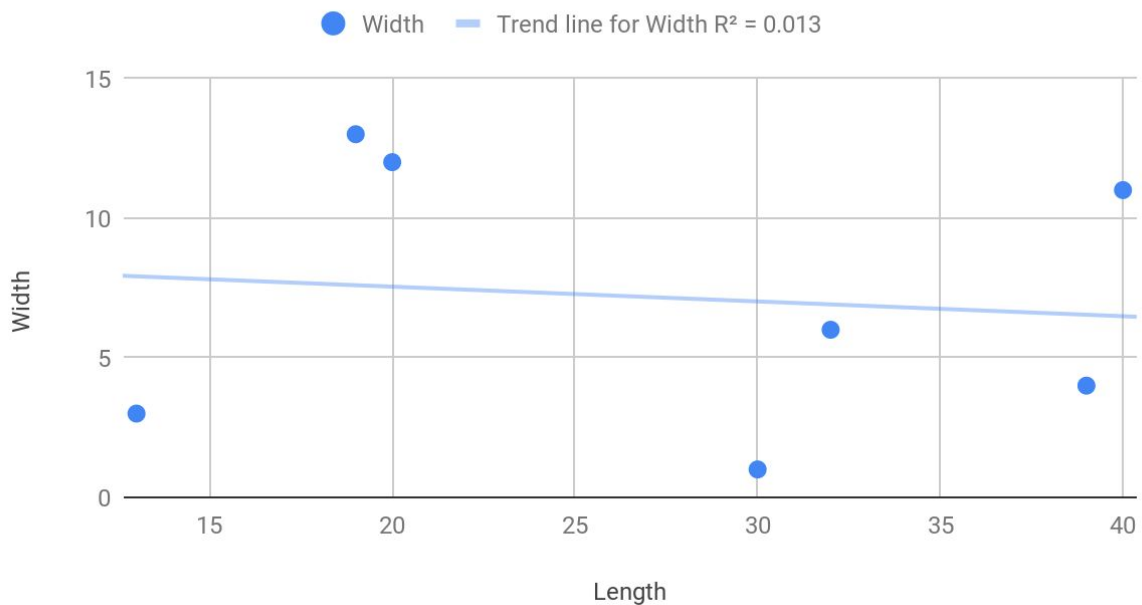
*Figure 12. Correlation of fin width and length*

Figure 12 shows the correlation between length and width of the corrosion fins.

There is a stronger correlation between height and length ( $R^2=0.279$ ) of the corrosion fins than there is between width and length ( $R^2=0.013$ ) of the corrosion fins.

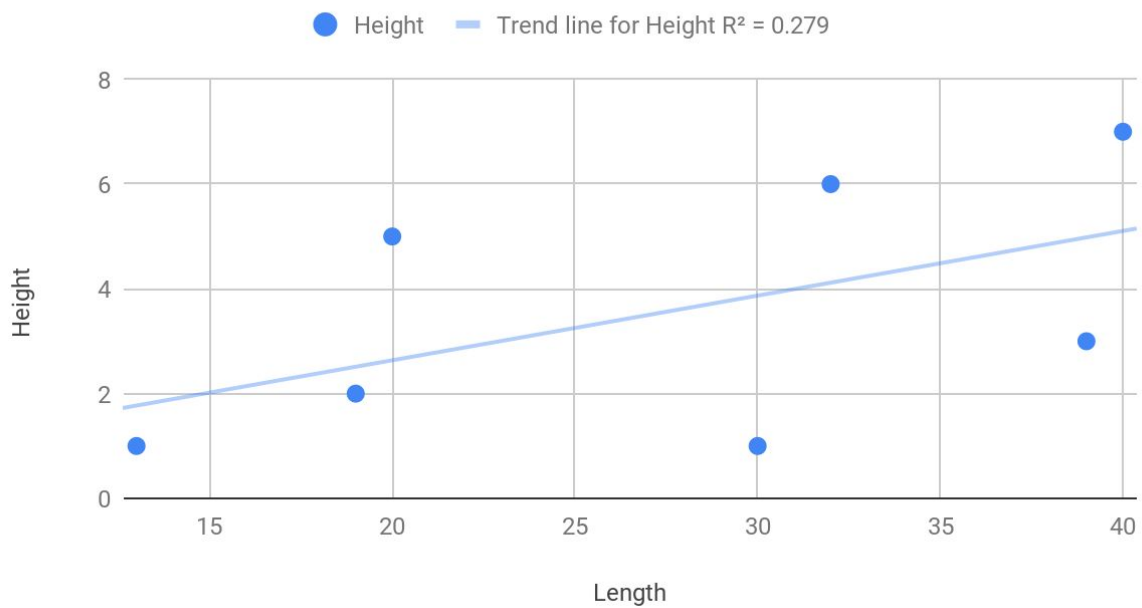
*Figure 13. Correlation of height and length*

Figure 13 shows the correlation between length and height of the corrosion fins.
