**Surveys of corrosion on cannons on the
wreck of the Coronation**

BSAC First Class Diver Examination

25th and 26th June, 2011

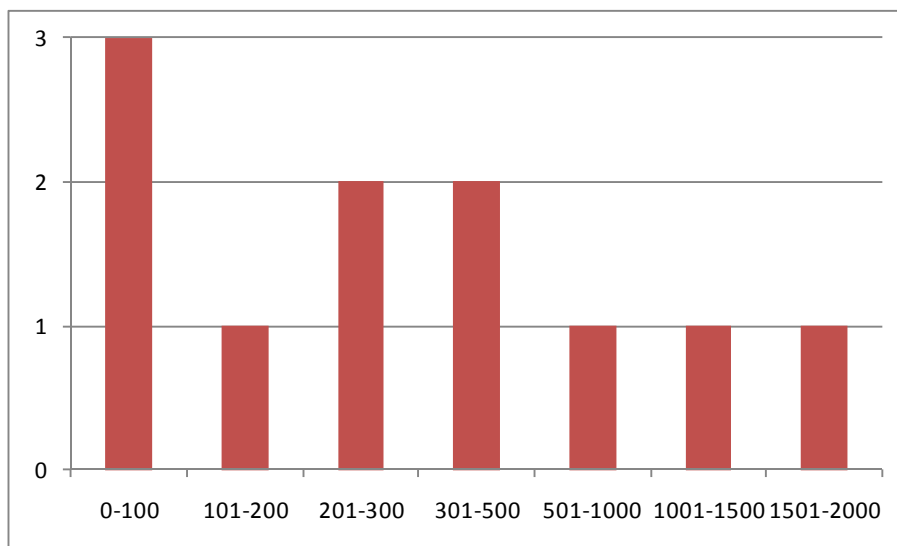
Figure 1: Frequency of eruption length

Figure 1 shows the distribution of length of eruption, it can be seen that the eruptions range from less than 100mm to over 1500mm in length. The smaller eruptions are most frequent but there is a broad range of sizes across the survey site.
